HISTORIC PRESERVATION COMMISSION STAFF REPORT

TO: CASA GRANDE HISTORIC PRESERVATION COMMISSION
FROM: Laura Blakeman, City Planner
MEETING DATE: May 26, 2015
SUBJECT: DSA-15-00054: Certificate of Appropriateness

1. **DSA-15-00054:** Certificate of Appropriateness for the replacement of 6 windows at 806 N. Brown Avenue, a property located within the Evergreen First Addition Historic District.

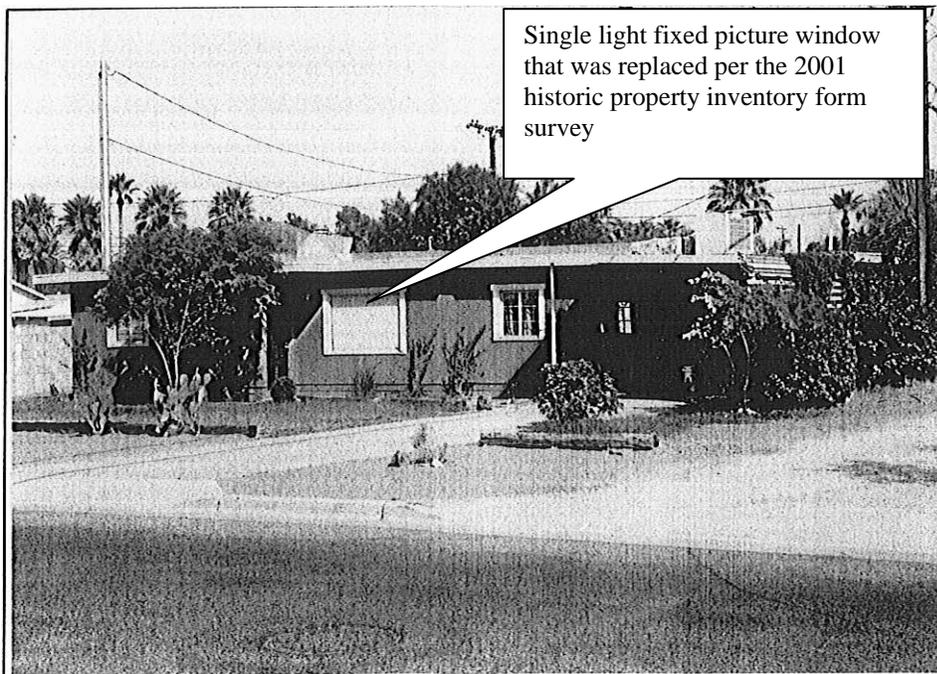
The exhibit below shows a picture of the house taken in 2001 for the Historic Property Inventory form. The form indicates that one of the front windows was replaced as a single-light, fixed picture window.

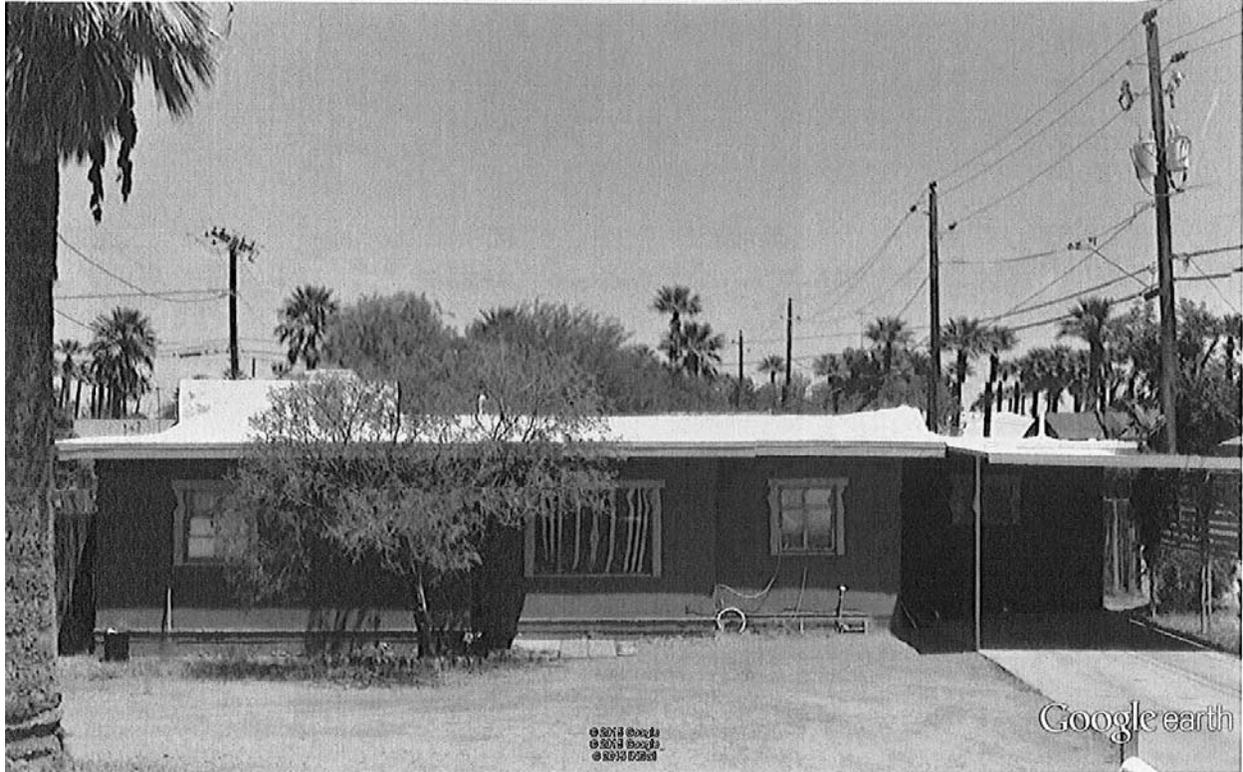
The following exhibit shows the house from the Google Earth website prior to the windows being replaced this year.

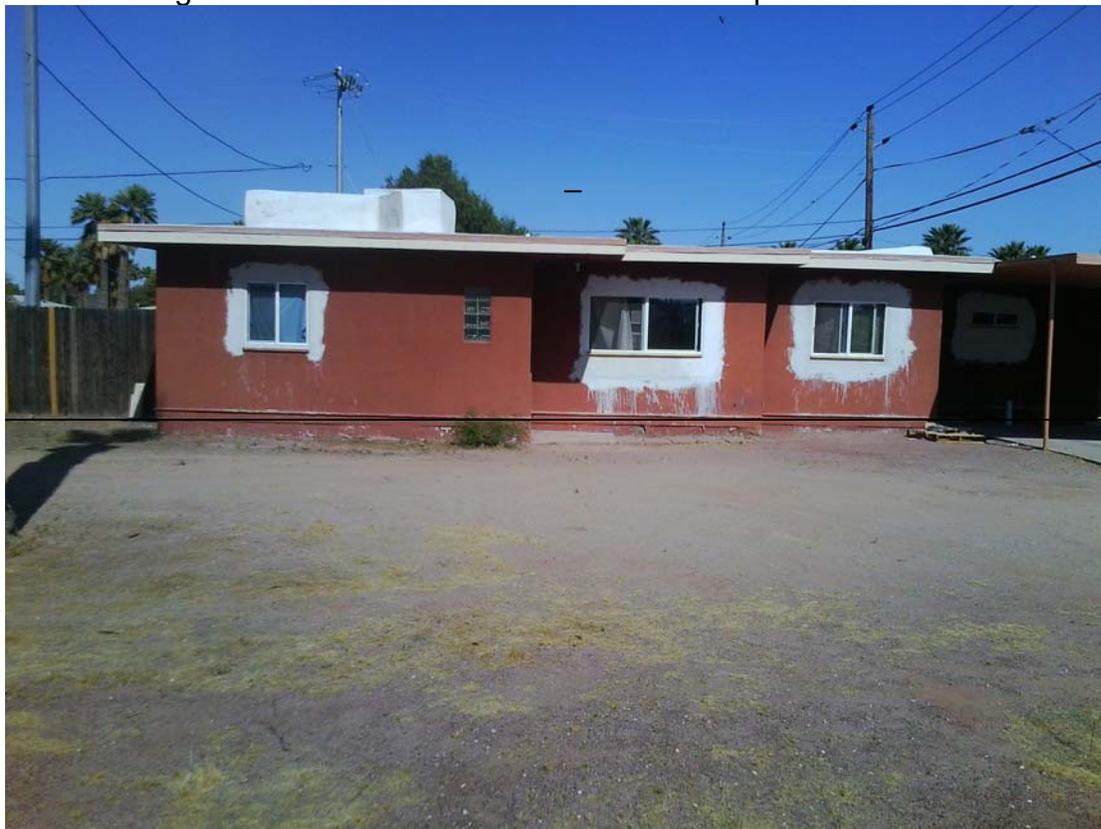
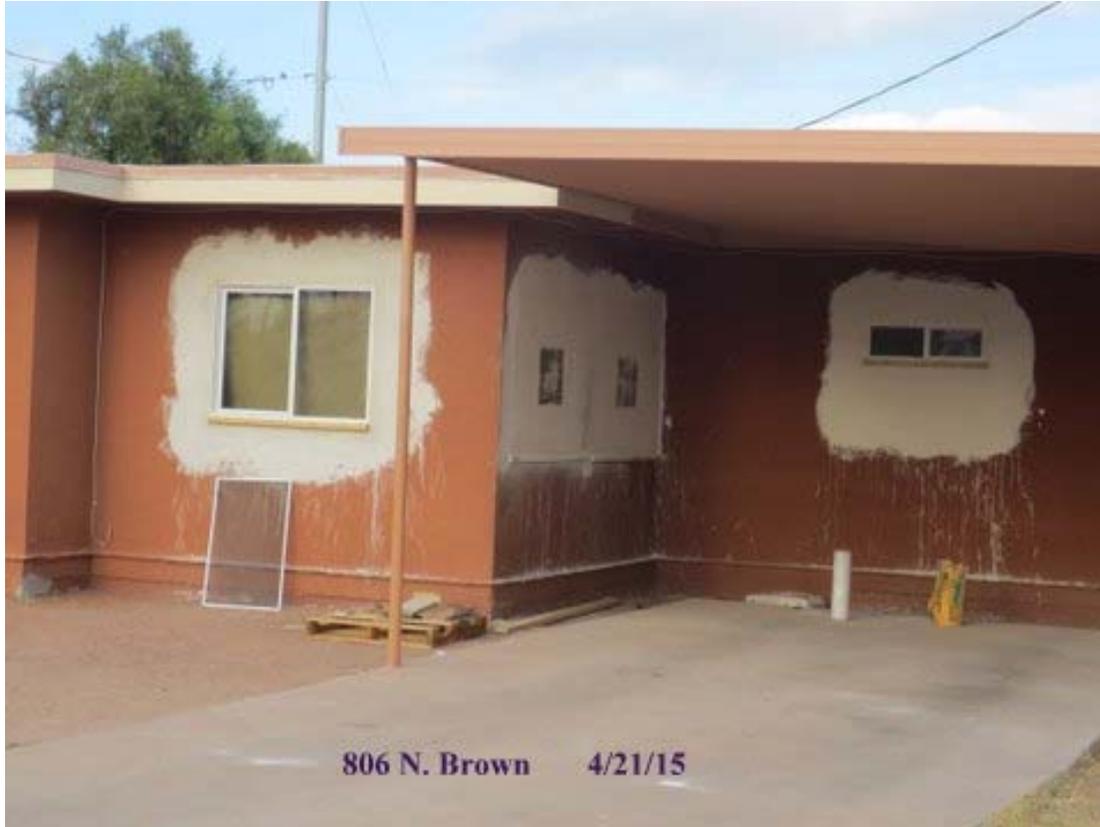
The following exhibit shows the windows that were replaced last month.

Staff has determined that the replacement windows do not match the historical style of the home and the historic character of the district.

Windows are significant characteristics that contribute to the properties historic character, however the new windows do not retain the same characteristics of the original windows in regards to size and style (window grids, pop outs and ledges).

None of the proposed alterations affect the building's scale; however it appears that some of the windows have been altered in size.

Staff recommends the Historic Preservation Commission deny the Certificate of Appropriateness (DSA-15-00054) based on the following factors:

1. The size and style of the windows have been modified.
2. The areas around the windows (pop outs and ledges) have been removed.

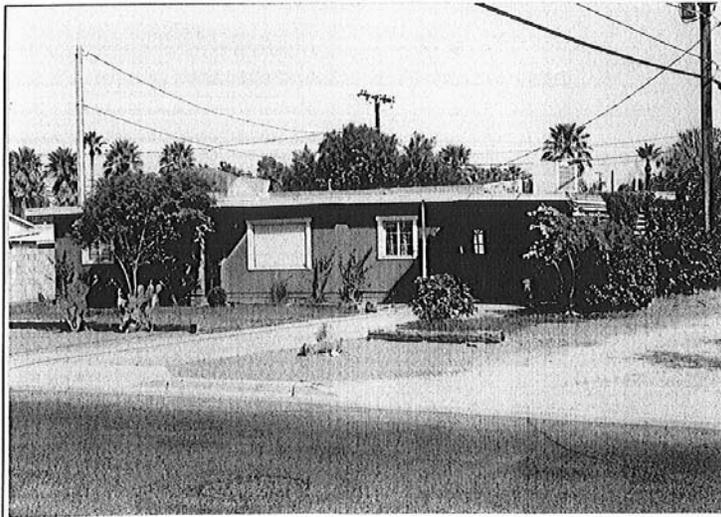
Date of Photo: 10/18/01

View Direction: Northeast
(looking towards)

One window on the front façade is a replacement single-light, fixed picture window.

Walls (structure): Not visible **Walls (sheathing):** Stucco and wood window surrounds
Windows: Multi-light metal casement windows, single light fixed picture window
Roof: Roof itself not visible; wood fascia and metal flashing **Foundation:** Concrete

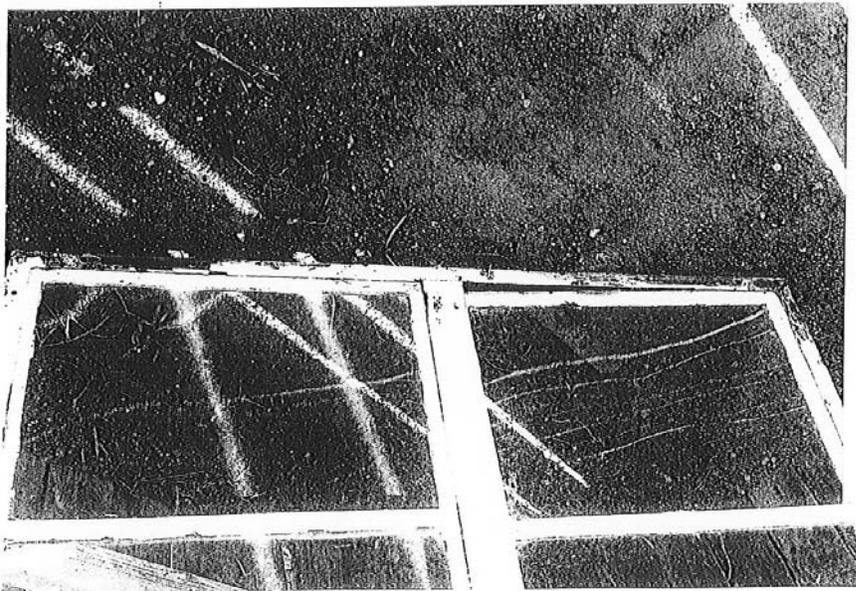
Missing crank
Rusted & deteriorated metal

original trim
should be only
at the lower ledge.
Same as other homes
in the neighborhood.

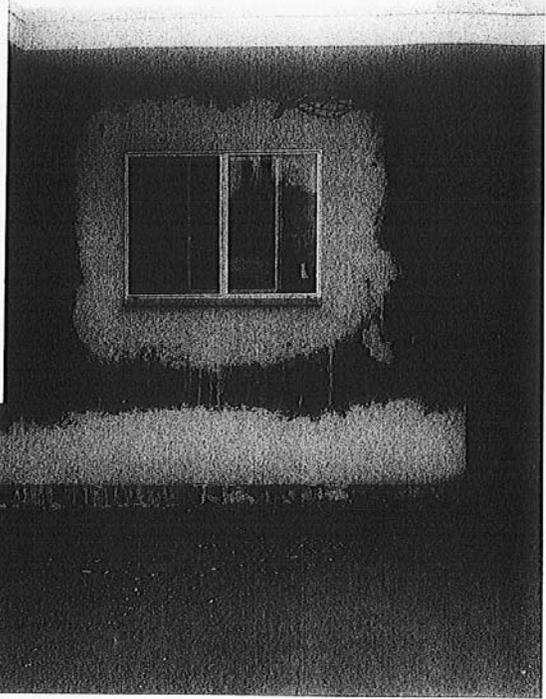
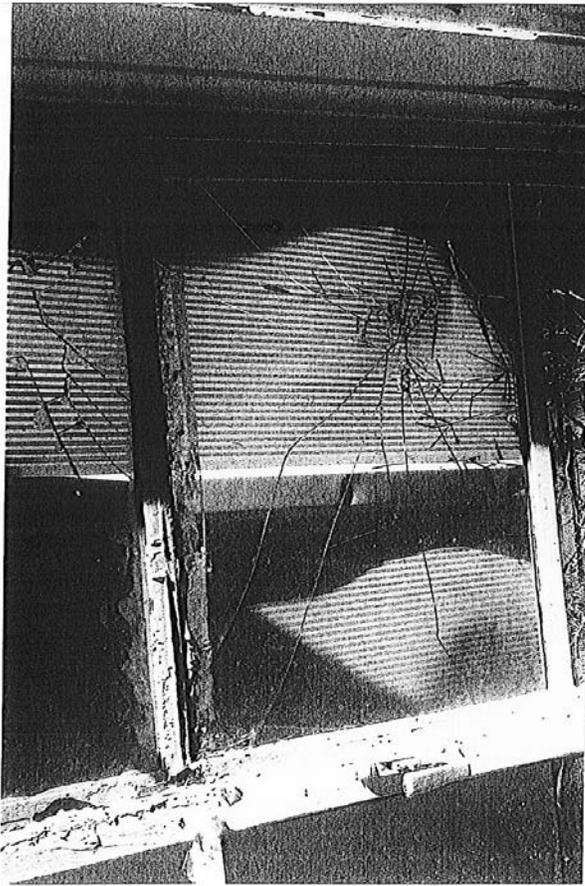
Cracked window;
glued & welded window

Replaced cracked windows and non operating Window
