HISTORIC PRESERVATION COMMISSION STAFF REPORT

SUBJECT: DSA-14-00164: Certificate of Appropriateness

1. **DSA-14-00164:** Certificate of Appropriateness for renovations to Lupita's Mexican Food Restaurant (A.K.A. Johnson's Grocery Store, Sofia's Mexican Kitchen) a historic building listed on the local and national registers located at 301 N. Picacho Street.

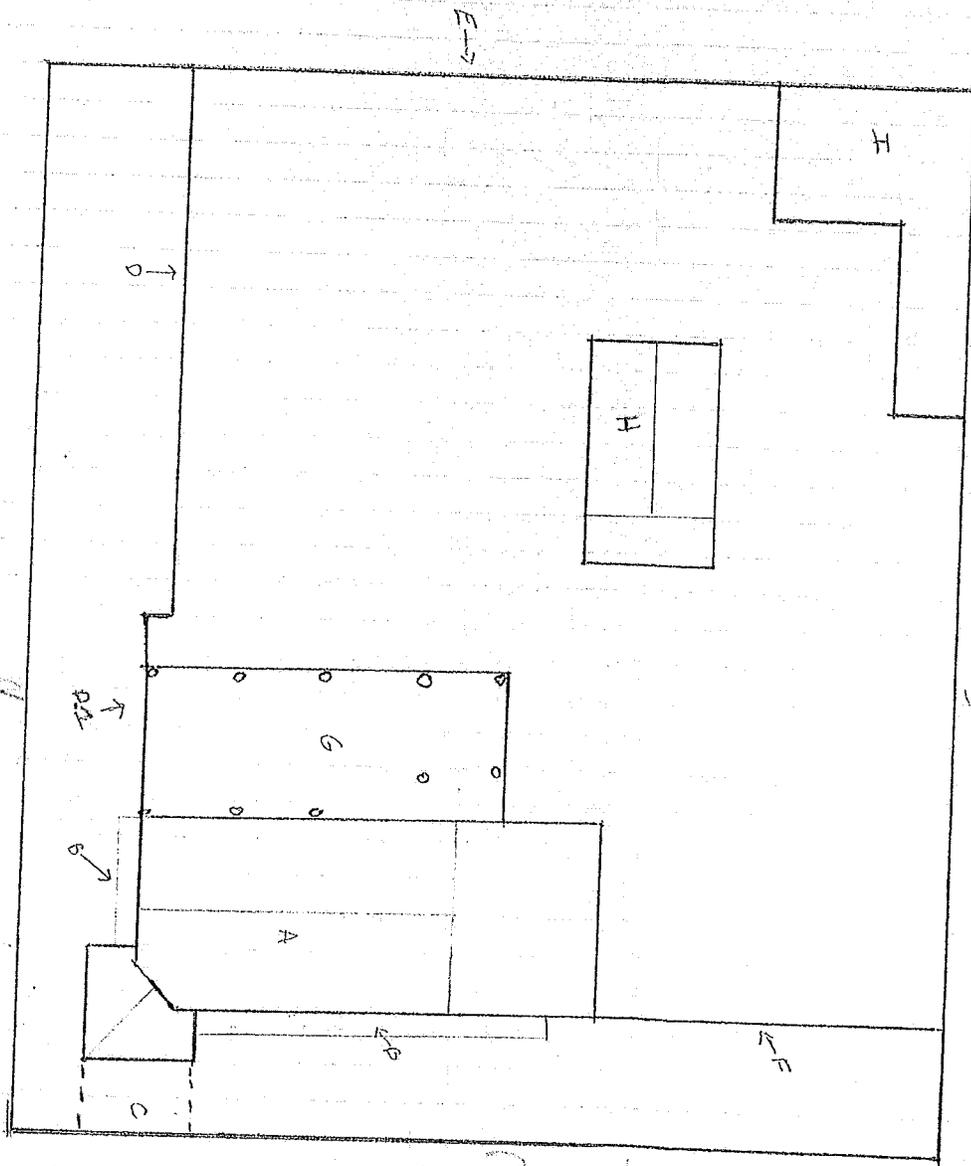
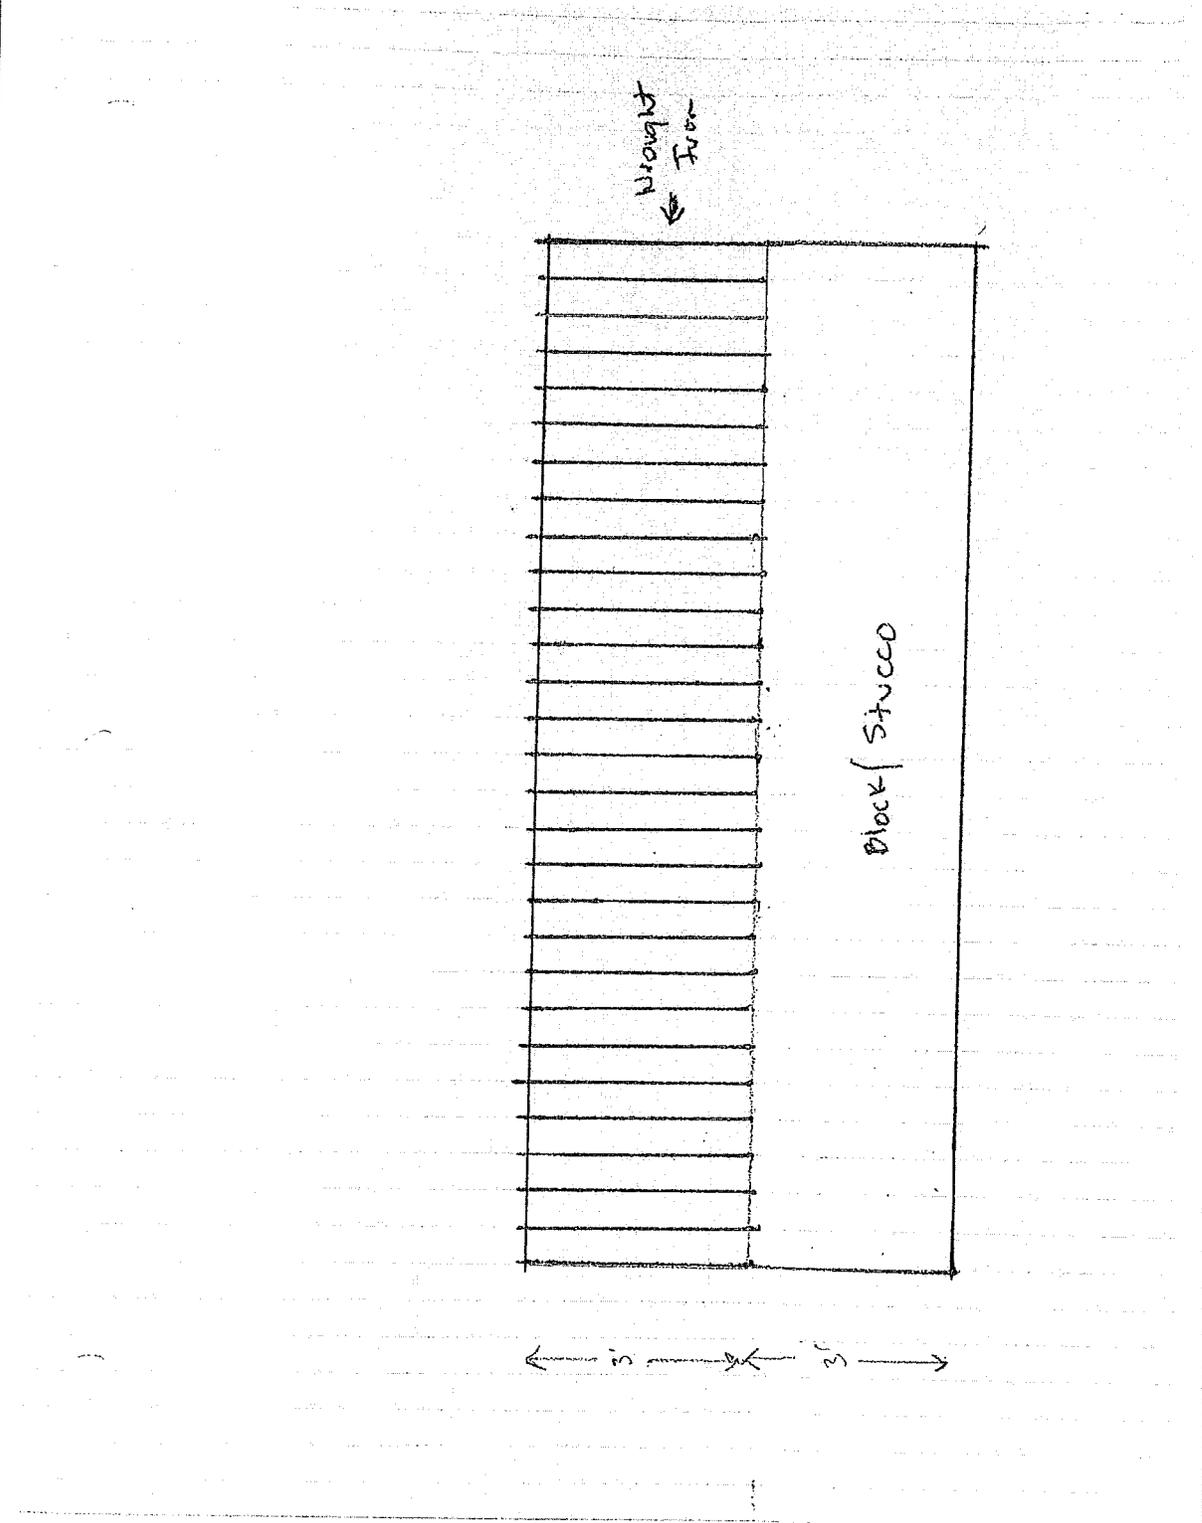
- A. Existing roof material is corrugated steel; replace with rustic red steel R-panel
- B. Demo existing 4' wide sidewalks on N and W side of building
- C. Pour new sidewalk 15' x 11' from existing covered entry to city sidewalk
- D. Demo existing corrugated metal fence and replace with 3' block wall with 3' of wrought iron on top. Same as existing to west (D.1)
- E. Demo existing chain link fence and replace with 6' block wall.
- F. Demo existing corrugated steel fence and replace with 6' block wall.
- G. Existing patio columns of wooden poles and frame work to remain. New sunshade material made of knitted polyethylene to be installed to replace ripped material. Stained concrete poured under shade.
- H. Existing storage building
- I. Existing storage building

In addition, the site will also involve maintenance and painting of the exterior as necessary.
