BID PROPOSAL

**Project Owner: Betty Jean Edwards
Project Address: 1133 East 5th Street, Casa Grande, AZ 85122**

1. Approved Rehabilitation Plan Set and Scope of Work

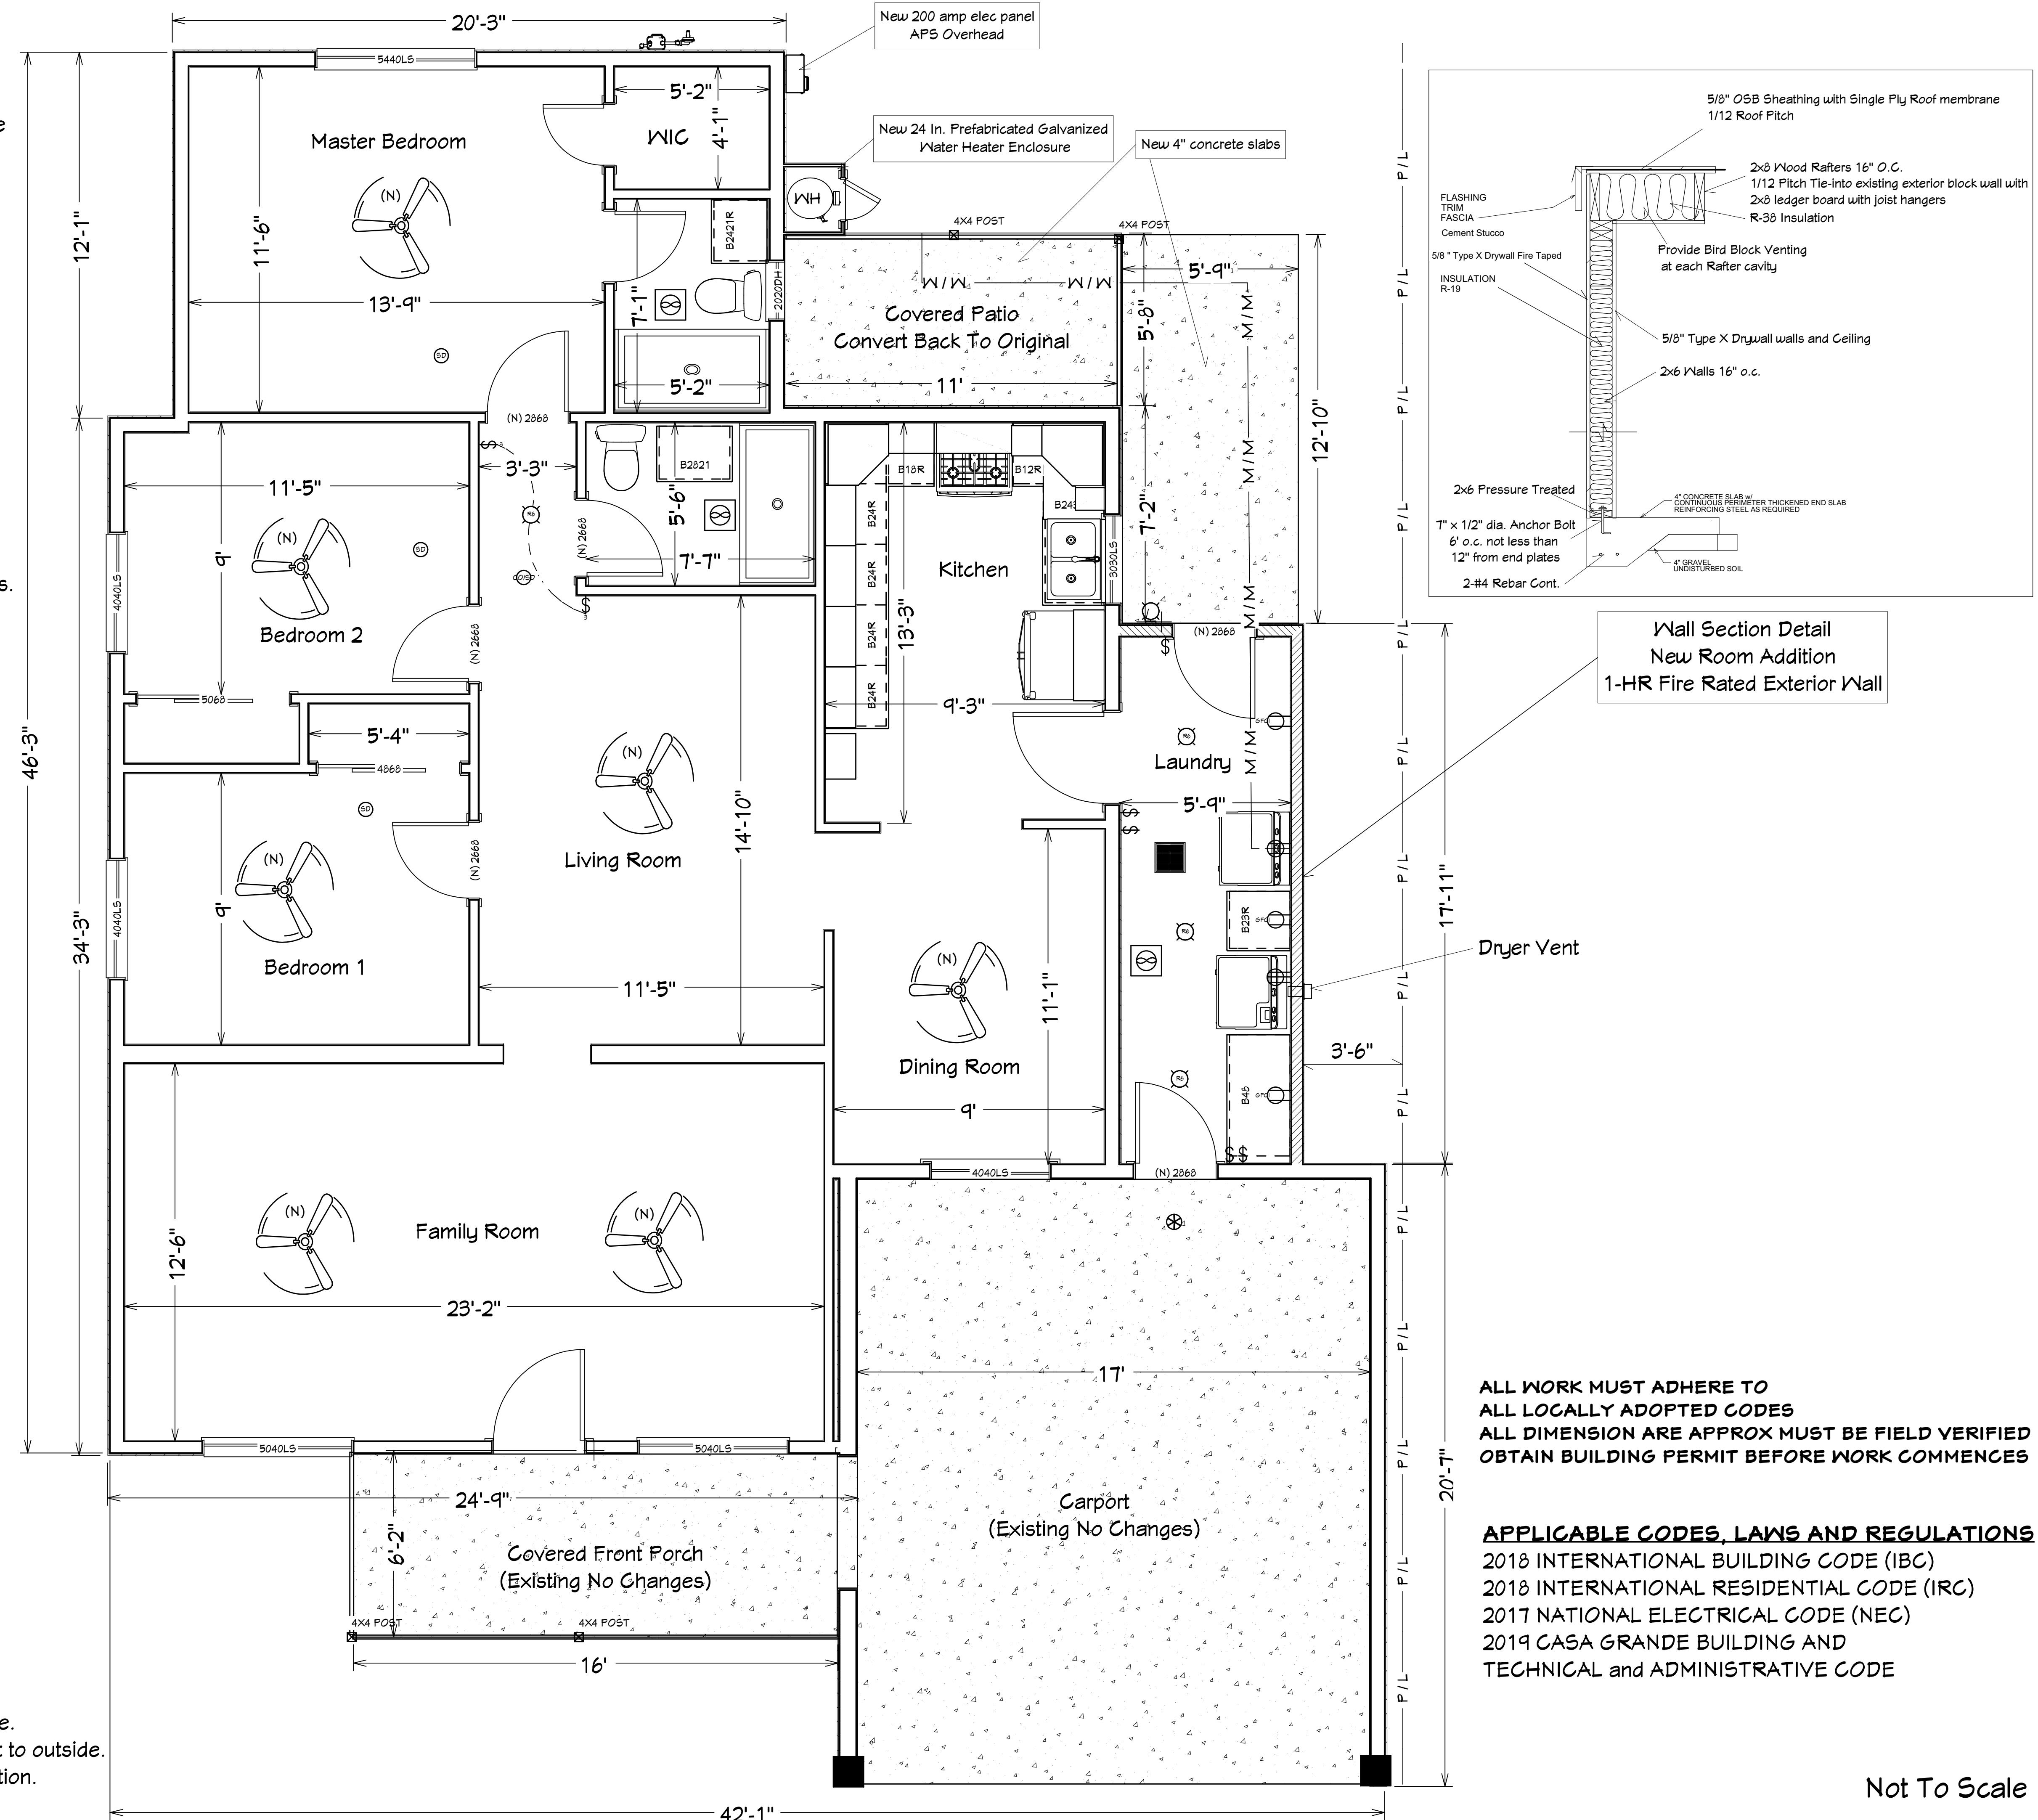
A-2

-Install new exhaust fan in mast bath and laundry room. Duct to outside.

-Perform air balance test prior to final inspection and completion.

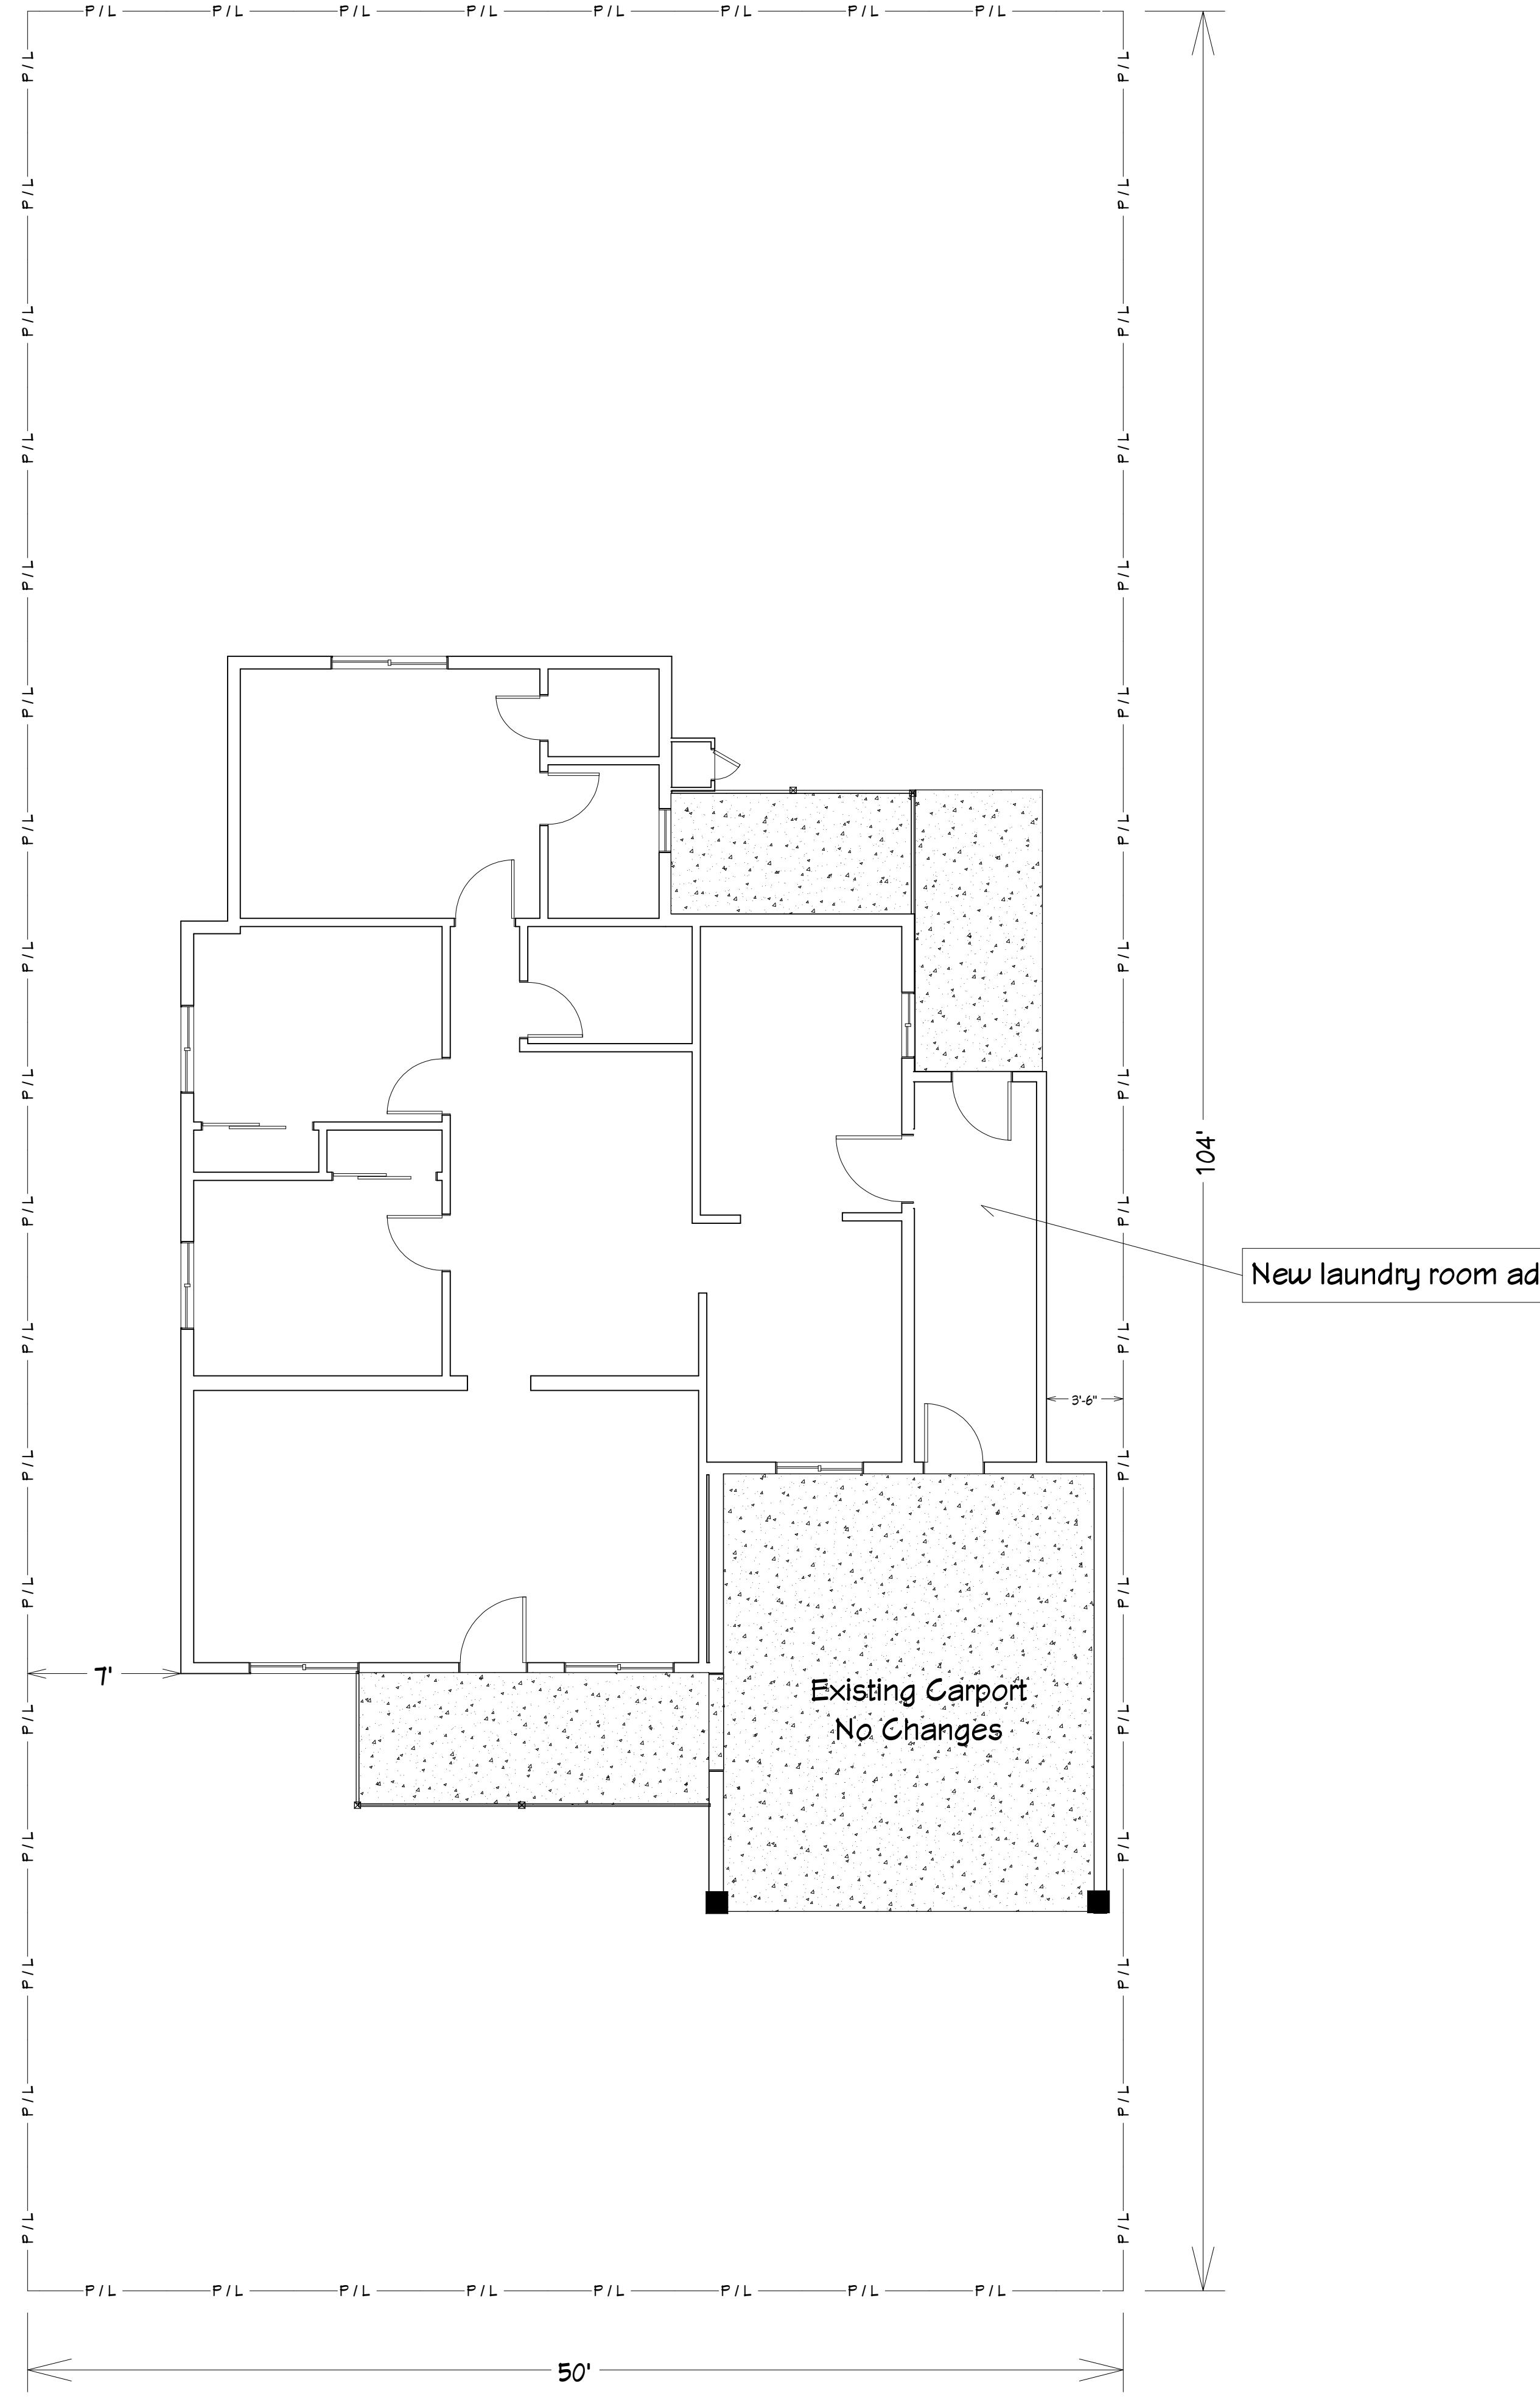
New Site Plan

Exterior:
Repair and waterproof damage areas of the stucco walls.
Re-work back covered patio to original condition. Remove all electrical and plumbing from laundry area and relocate to new room addition.
Replace any rafters, posts or beams as needed upon discovery.
Remove and re-pour new concrete slab at back covered patio.
Install new 4" thick concrete sidewalk from new room addition to back covered patio. (per plan)
